OBSERVATIONS OF PROPAGATING STALL
IN AXIAL-FLOW COMPRESSORS

T. Iura and W. D. Rannie

Report No. 4

April 1953

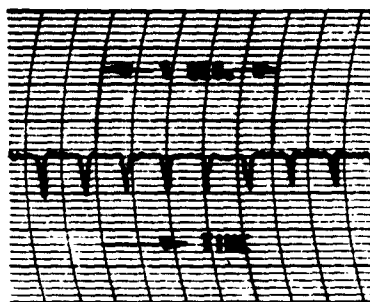
ONE-REGION PARTIAL STALL, $\Phi = 0.397$, INITIAL STALL POINT AT CLOSING THROTTLE,
PROPAGATING STALL SPEED = 38 PERCENT OF ROTOR SPEED

TWO-REGION PARTIAL STALL
 $\Phi = 0.38$, $R/R_0 = 0.65$
 $\omega_s = 0.38 \omega$

THREE-REGION PARTIAL STALL
 $\Phi = 0.36$, $R/R_0 = 0.65$
 $\omega_s = 0.38 \omega$

FULL STALL
 $\Phi = 0.29$, $R/R_0 = 0.65$
 $\omega_s = 0.26 \omega$

ONE-REGION PARTIAL STALL, $\Phi = 0.39$
 $R/R_0 = 0.65$, $\omega_s = 0.38 \omega$, FAST CHART SPEED

THREE-REGION PARTIAL STALL, $\Phi = 0.34$
 $R/R_0 = 0.65$, $\omega_s = 0.38 \omega$, FAST CHART SPEED

EXAMPLE OF UNSTABLE STALL PATTERN AT TRANSITION POINT. THROTTLE SETTING UNTOUCHED.
CHANGE FROM FULL STALL TO THREE-REGION PARTIAL STALL WITH INTERMEDIATE FOUR-REGION
PARTIAL STALL PATTERN. OPENING THROTTLE, $\Phi = 0.339$, $R/R_0 = 0.611$, CONSTANT RPM.

FIGURE 14: OSCILLOGRAPH RECORDS OF PROPAGATING STALL. THREE-STAGE FREE VORTEX BLADING,
BEHIND THIRD ROTOR ROW, 750 RPM

the observed frequency increased to about 9.4 cycles per second, and on further throttling, became 14.1 cycles per second. Fig. 14 shows examples of the chart data obtained with the oscillograph. The principle types of partial stall patterns are shown as they appear with two different chart speeds of 25 mm per sec. and 125 mm per sec. The one-region partial stall fluctuations are shown at three different radii, and it can be seen that the fluctuations disappear entirely at mid-radius. The magnitudes of the instantaneous velocities, as measured, show strongly retarded flow regions that can result only from flow separation (stalling) on the blades. The mean velocity \bar{V} is the average of the instantaneous velocities with respect to time over a complete cycle as determined by the mean resistance of the hot-wire. For velocity fluctuations large compared with the mean velocity, this procedure introduces some error. The portions of the velocity traces above the chart center line in general correspond to unretarded flow, while those below correspond to retarded flow. The amplitude of the velocity fluctuation ΔV was taken as the difference of the minimum velocities in the unretarded and retarded flow regions. The radial distribution of the velocity fluctuation amplitude ratios, $\Delta V/\bar{V}$, are shown in Fig. 15.

When the throttle was opened from the full stall point, the above patterns appeared in reverse order, although the limits of ranges of succeeding patterns occurred at larger flow rates than on closing throttle. The three-region pattern appeared at $\bar{\Phi} \cong 0.34$ and the one-region pattern disappeared at $\bar{\Phi} \cong 0.41$. In one instance, four symmetrical propagating stall regions appeared on opening the throttle from the full stall. Although well-defined, the pattern was soon replaced by the three-region pattern without touching the throttle (see Fig. 14).

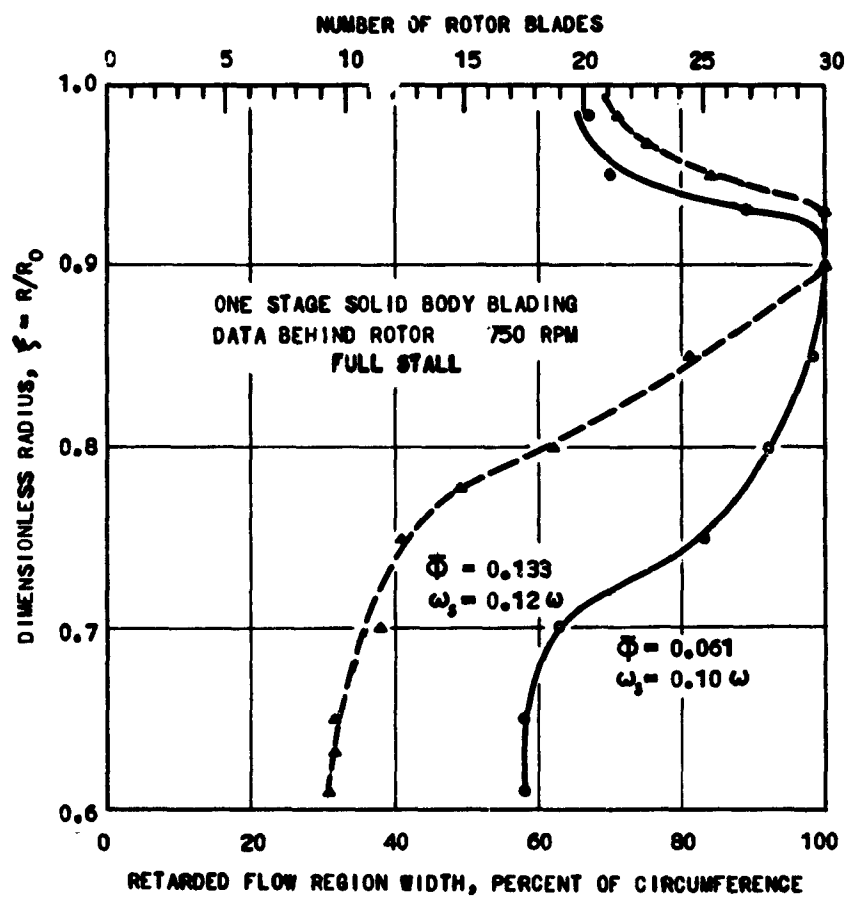
FIGURE 44
RADIAL VARIATION OF RETARDED FLOW REGION WIDTH
